FACE INVESTIGATION

SUBJECT: Farmer Dies of Entanglement in Corn Picker/Husker

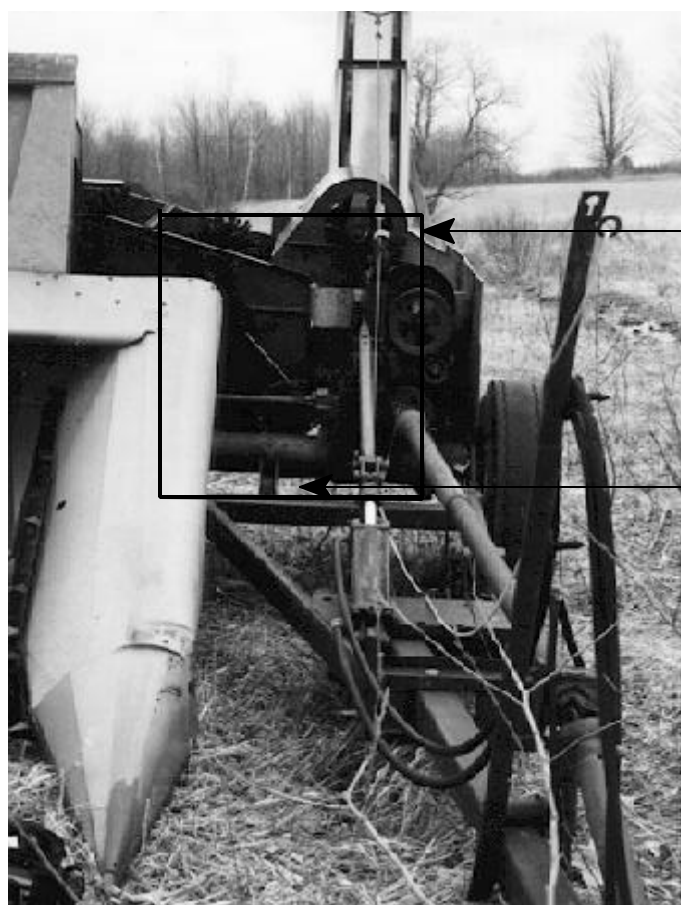
Figure 1

The farmer owned all of the equipment that he used in harvesting, transporting and storing corn. He was using a tractor equipped with a PTO that powered the picker/husker, and he also had attached a grain wagon behind the picker. He had purchased the used, 17-year-old corn picker/husker from a farm equipment dealer 12 years before the incident, and had used it each harvesting season since then. At the time of purchase, it was equipped with metal housing guards over portions of the sprockets and chains on the sides and back of the machine that were still in place at the time of the incident. Exposed sprockets, chains and a shaft were present on the left side and on the recessed front portion of the picker/husker (Figure 1).

See top view (Figure 2)

Discussion: In this case, metal housing guards had been installed over portions of the sprockets and chains on the corn picker/husker, but other moving sprockets, chains and shafts were exposed during the equipment's operation. Unguarded moving belts, sprockets, chains, and rotating shafts expose workers to entanglement resulting in injuries and even death. If retrofit guards had been installed over the exposed shaft, the incident may have been avoided. To prevent installation of an inadequate guard, machine/equipment owners should consult with the manufacturer or dealer before installing any guard.

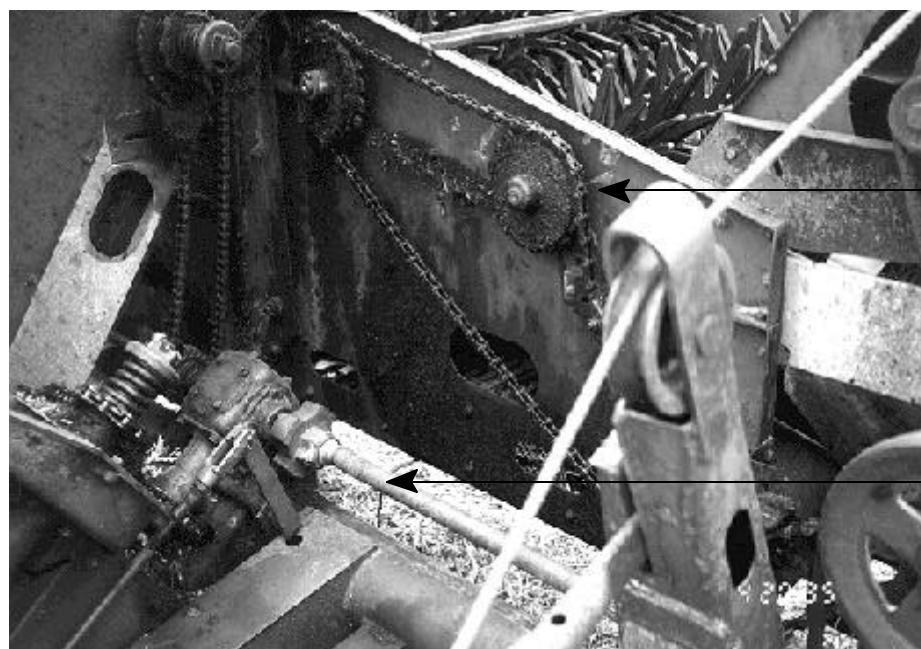
Figure 2

The incident was unwitnessed, but it is assumed the victim got off the tractor while the tractor was running with the PTO engaged, and was positioned near the recessed front portion of the picker/husker close to the rotating shaft (Figure 2). Soil beneath the picker/husker was covered with icy patches, possibly causing the victim to slip and fall into the operating parts of the machine. His coverall apparently was caught by the shaft, pulled partially from his body, and drew the victim toward the shaft and the gear chains. His wife noted that the tractor was stopped and she returned to the field to investigate. She found the victim entangled in the picker/husker, shut off the PTO, and went to the house to summon emergency services. EMS responders arrived and disengaged the PTO from the picker/grinder shaft to free the victim from the machine. The victim was pronounced dead at the scene.

Location of victim

Chain and sprockets

Shaft

Discussion: In this incident, the victim was operating a corn picker/husker driven by a PTO, and became entangled and died. When operating PTO driven equipment, the PTO should be disengaged and the tractor engine shut off before dismounting or leaving the tractor to approach the equipment. These precautions provide the operator protection from contact with the moving machine parts and from the unexpected engagement of power when an operator is cleaning, servicing, adjusting, or repairing the equipment. If the PTO had been disengaged and the tractor engine stopped before the victim approached the picker/husker, this fatality would have been prevented.
